# Home Inspection Report

**Property Address:  
123 State Street  
Anytown ME 01234**

**S & J Property Services, LLC**

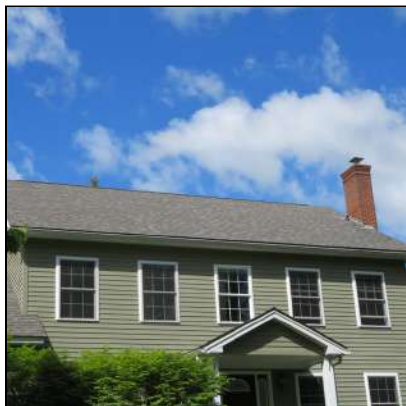
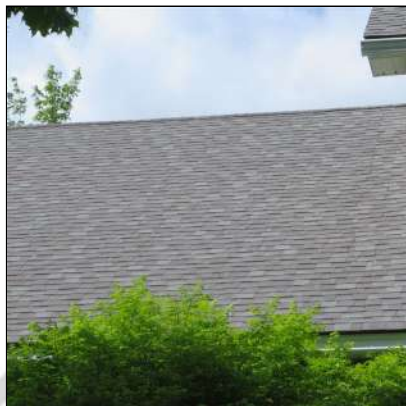
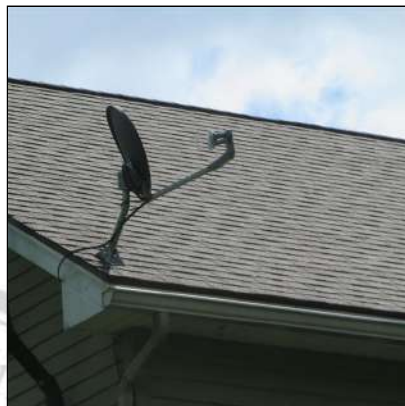
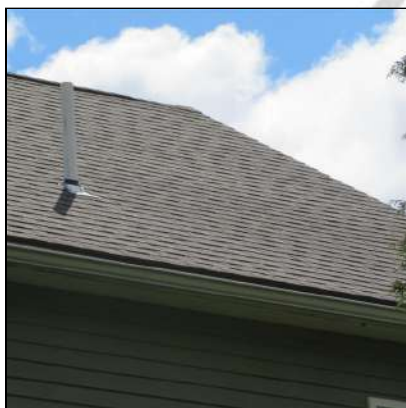
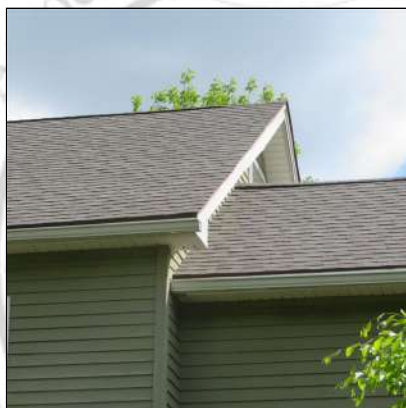
**1.0** (1) According to the disclosure, the shingles were installed in 2007 after a fire on the "3rd floor" of the house. The average life expectancy of architectural fiberglass/asphalt shingles is 25 to 30 years. This is not a warranty or guarantee of the life expectancy of the roof on the property which is the subject of this inspection. The life of a roof depends on local weather conditions, building and design, material quality, and adequate maintenance. Roofs in areas which experience severe weather may experience a shorter-than-normal lifespan overall or may incur isolated damage which requires repair in order to ensure the service life of the surrounding roofing materials.

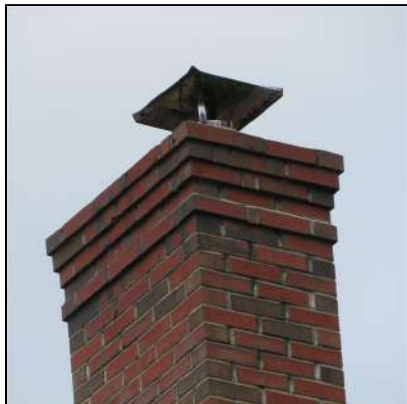
**1.3 (2)** I recommend a cap be installed for the entire chimney top, to keep rain, snow, animals and debris from getting into the chimney and possibly damaging the liner or chimney.

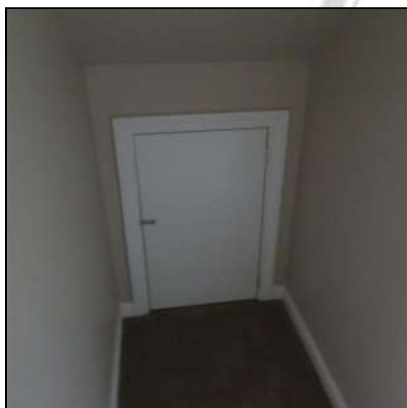
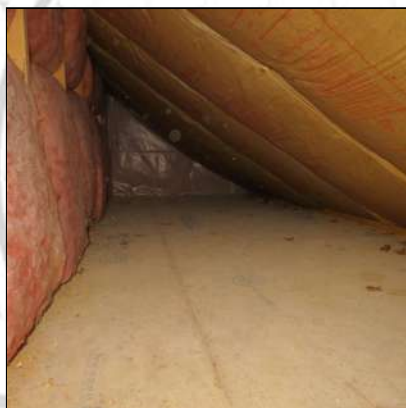
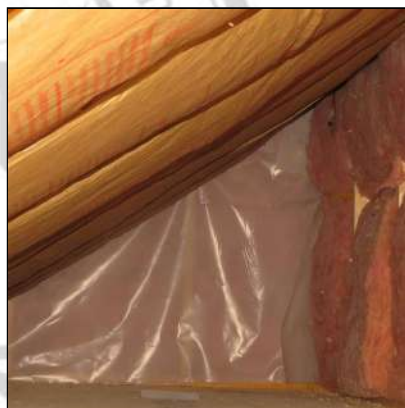
**1.4 (1)** No access to attic over main house. Access to area behind knee wall on 3rd floor, but roof structure not visible due to insulation. This prevented me from inspecting the interior side of roof structure, ventilation, insulation or any electrical above the ceiling of the main house. Please refer to Section 10.3 regarding attic over garage. I recommend inspection of attic over main house if an opening is made for repairs or renovations.

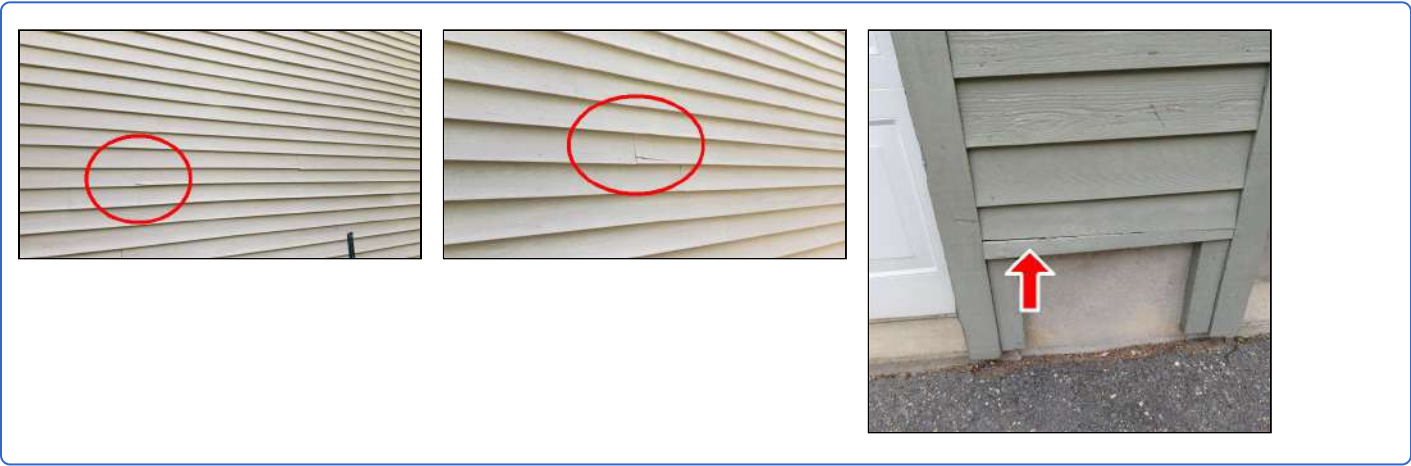
**2.0 (2)** Small areas of bare wood on siding on rear of house. Also several pieces of clapboard siding have cracks. Recommend any bare wood be primed and painted and cracks sealed or siding otherwise repaired to prevent moisture intrusion and extend life of siding.

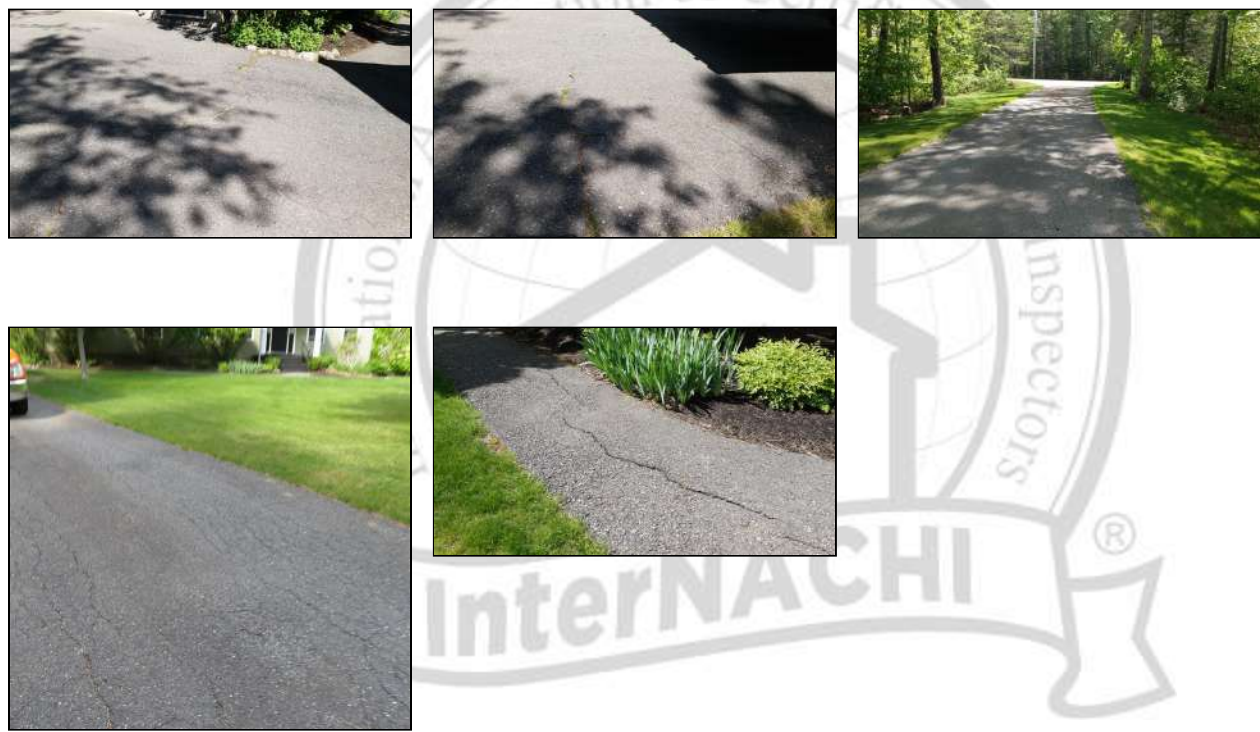
2.2 (2) Asphalt driveway and walkway is functioning, but multiple cracks and some heaves. Recommend any significant cracks be sealed or repaired to avoid water intruding beneath asphalt.

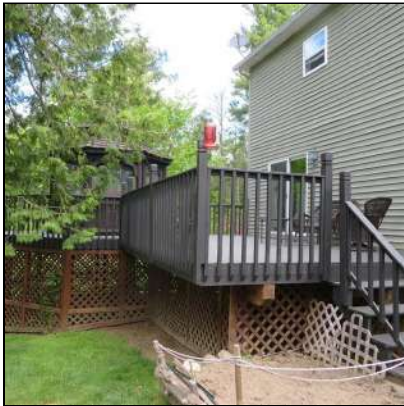
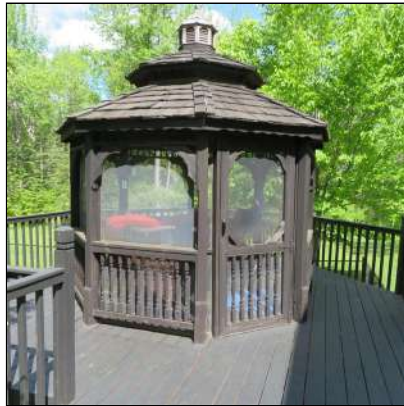
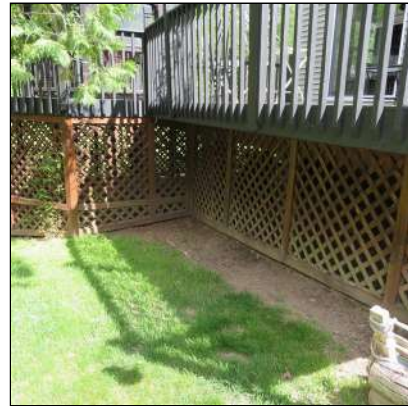
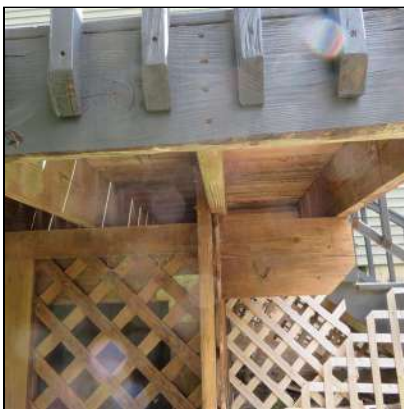
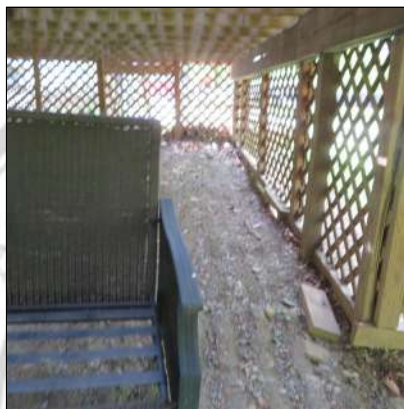
**2.3 (1)** Recommend deck surface, railing system, framing, and support posts be inspected at least annually as part of regular maintenance schedule. Deck surface, railing system and stairs will require periodic maintenance to protect and extend useful life.

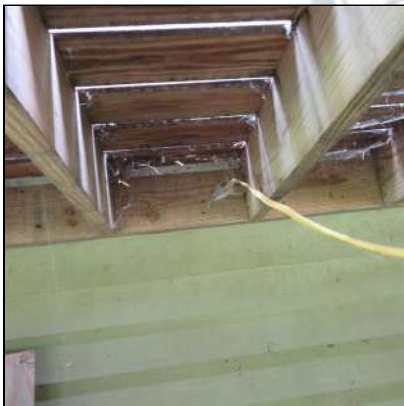
**2.3 (2)** Did not observe any bolts fastening ledger board for deck. Recommend lag bolts or other fasteners be installed to secure the ledger board to the house.

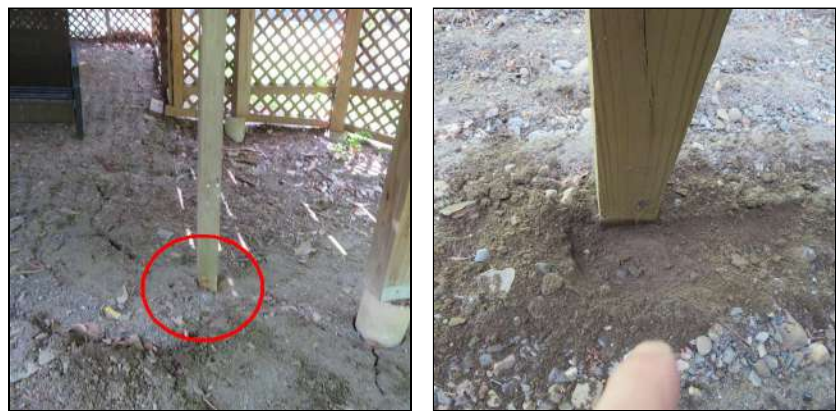
**2.3 (3)** Did not observe any concrete posts or pads under support columns for original deck. Recommend further inspection and if posts are not on concrete I recommend concrete pads be installed under all posts to extend useful life of posts.

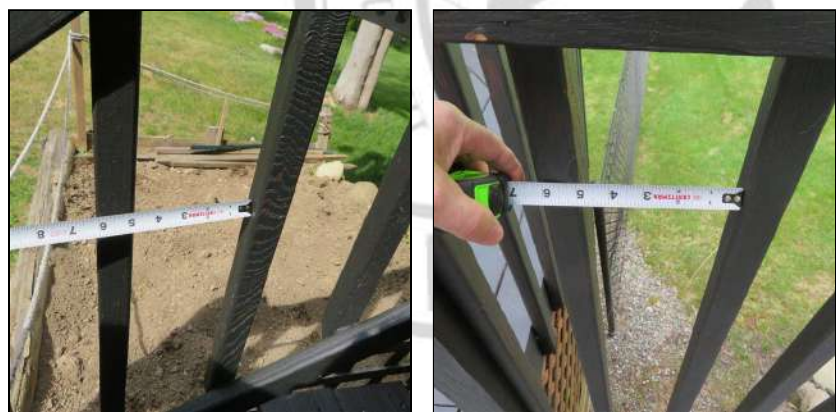
**2.4 (2)** Spacing of balusters for railing system for steps to deck and in areas of addition to deck where gazebo located exceed maximum 4" required by current safety standards. Recommend railing system be repaired to comply with current safety standards.

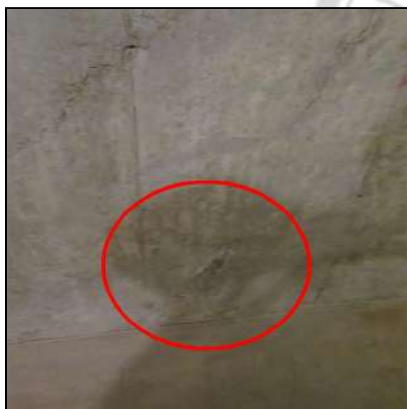
**3.0 (2)** Small area of white efflorescence (powder substance) on rear wall of basement near diagonal crack indicates moisture is in contact with the walls. This does not necessarily indicate that intrusion will occur. I recommend checking the gutters and the downspout drain lines for proper operation. Also, a water proofing paint could be applied to the interior side of the walls if necessary. Efflorescence is found on many homes without water intrusion occurring inside the home. But, it it raises possibility that future steps may be needed. Recommend area of efflorescence be monitored.

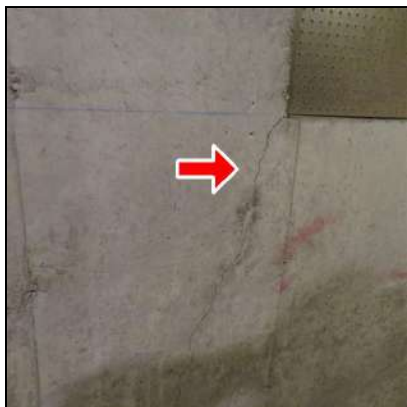
**3.1** Minor cracking in basement wall(s), but no evidence of any structural issues. Cracks of this type are common. Recommend cracks be monitored and if any 1/4" or larger that they be sealed.

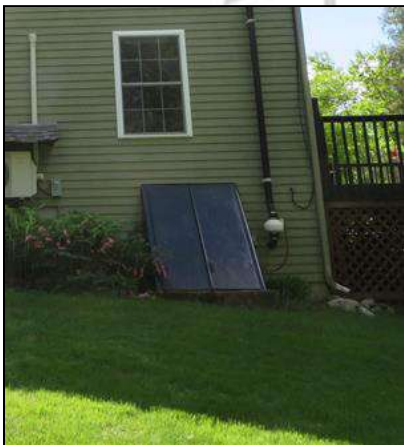
**3.7** Bulk head on right side of house. Unable to clearly observe the bulkhead due to insulation blocking view. Recommend bulk head be inspected once insulation is removed.

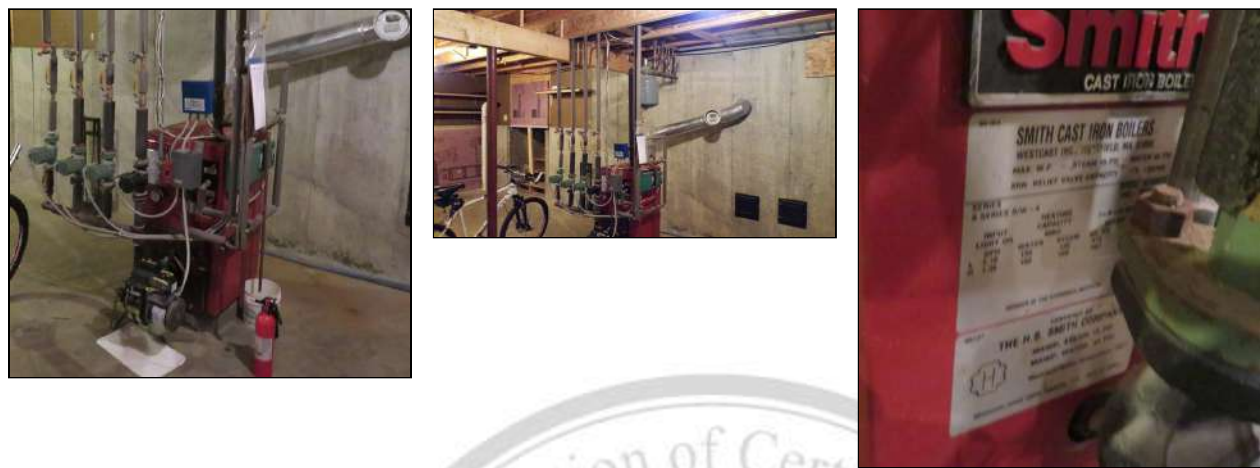
4.0 (1) Smith oil burning boiler. Unable to determine date of manufacture. The average life expectancy of a boiler is 40 years. The boiler has a Carlin burner. The average life expectancy of a burner is 10+ years.

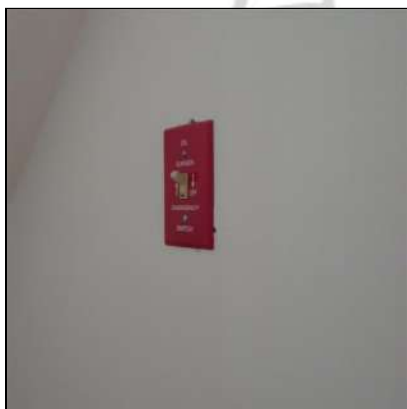
I also recommend the client(s) consider having the switch moved so it is not in same room as the heating system as is required by current Maine safety regulations.

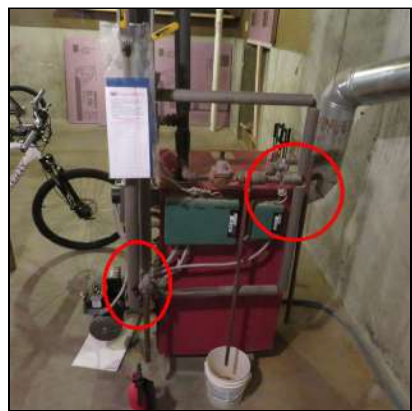
4.2 (2) The boiler is equipped with two temperature and pressure relief (TPR) valves. The valves will open if the temperature or pressure in the boiler exceeds limits set by the manufacturer. It is very important that the valves operate properly. To insure they are operating properly, I recommend the valves be tested at least annually.

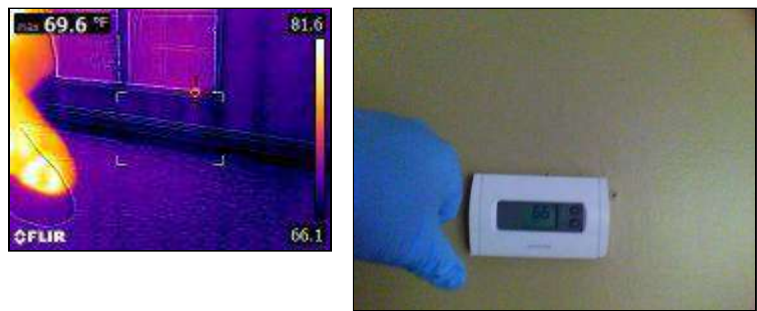
4.3 (2) Hot water baseboard for room over garage did not operate at time of inspection. Recommend further inspection ot determine if issue is with thermostat, a valve is turned off due to presence of heat pump or other cause. If repair is necessary recommend it be performed by qualified contractor.

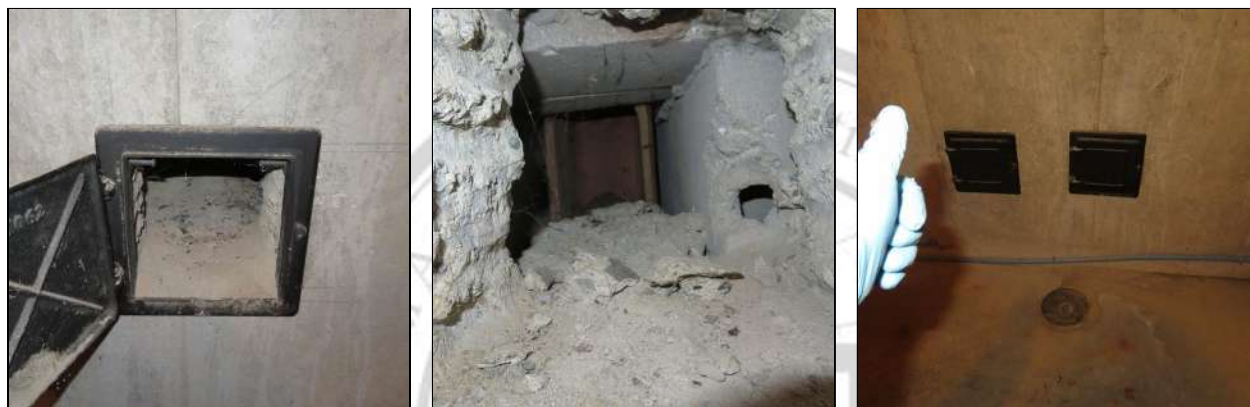
**4.5** According to the seller the chimney was recently inspected and cleaned. Unable to get clear view of chimney top or flues from clean outs. Chimney and flues should be periodically inspected by a certified chimney sweep as part of a regular maintenance schedule.

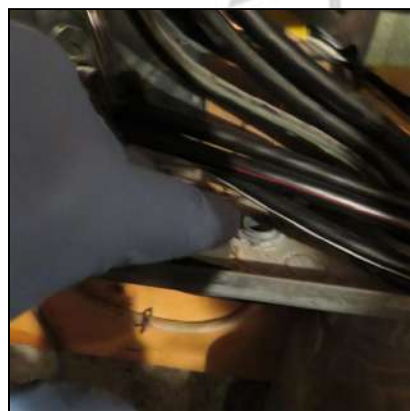
6.1 (3) Open knockout hole(s) on bottom of main service panel. Recommend proper plug/cover(s) be installed to prevent intrusion of pests and/or moisture.

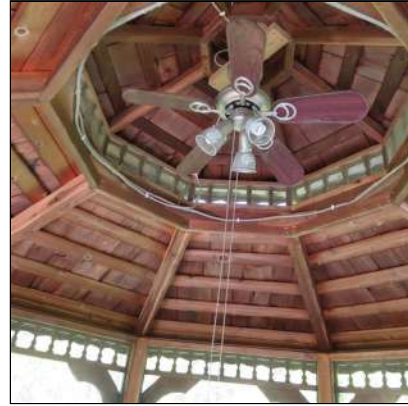
**6.3 (4)** Extension cord used to supply power to gazebo. Extension cords are not supposed to be used for permanent wiring. Recommend wiring to gazebo be hard wired and that any receptacles in gazebo be GFCI protected.

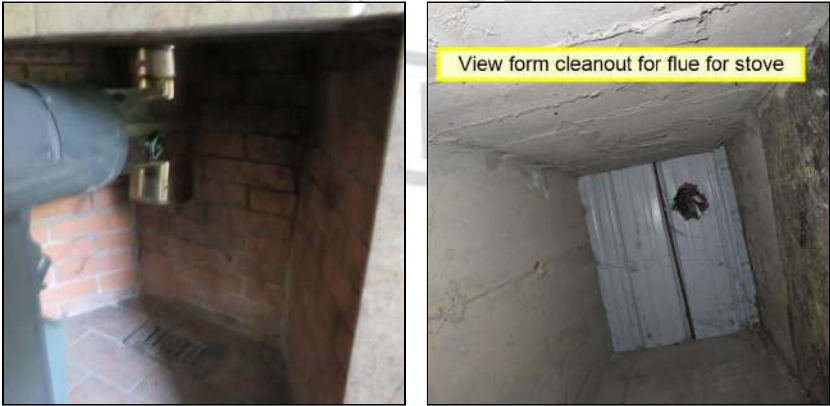
7.2 According to seller the chimney was inspected and cleaned shortly before the inspection. Unable to get clear view of chimney top or flues. Recommend the flue pipe for wood stove be inspected and cleaned on a regular basis by a certified chimney sweep if wood stove is going to be used and to follow his/her recommendations regarding future cleanings and/or inspections.

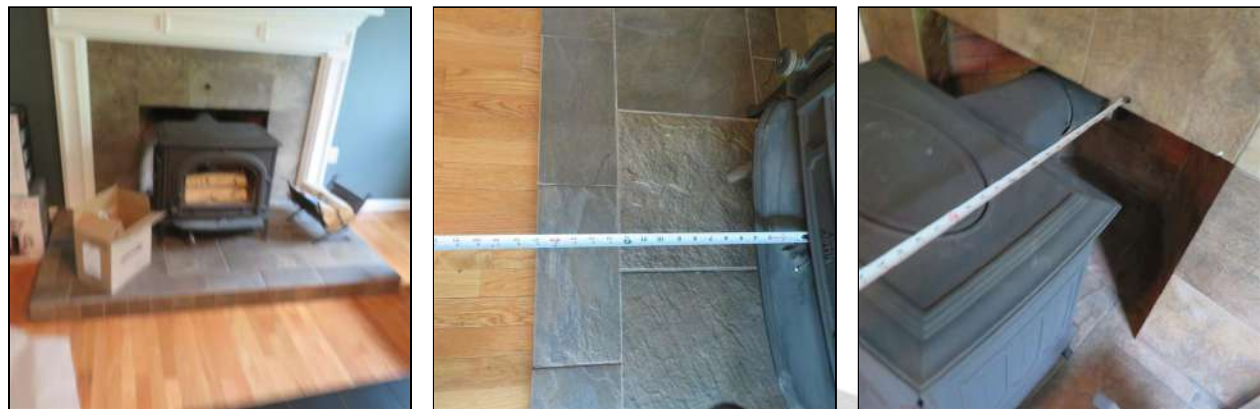
**7.3** Hearth/floor protector for wood stove is approximately 17" from the front opening of the wood stove and 9" from the side of the stove. A minimum of 18" from the front of a stove is required in most jurisdictions. Before the wood stove is used again, or any solid fuel heating device is installed in the fireplace opening, I recommend the client determine the requirements of the wood stove manufacturer and municipality where the property is located to determine the requirements of a hearth/floor protector and the clearance to combustibles.

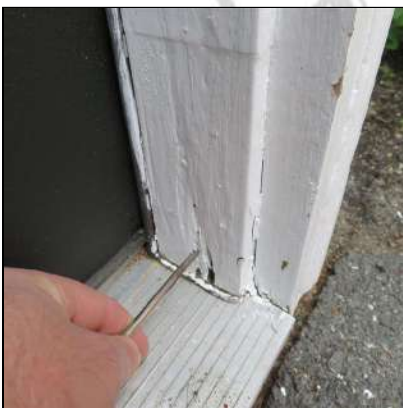
**10.4 (1)** Damage to trim for entrance door to garage. This is often caused by the failure to remove snow from the doorway. Please refer to Section 10.11. Recommend that damaged wood be repaired or replaced as necessary by a qualified contractor.
