# Home Inspection Report

**Property Address:  
123 State Street  
Anytown ME 01234**

**S & J Property Services, LLC**

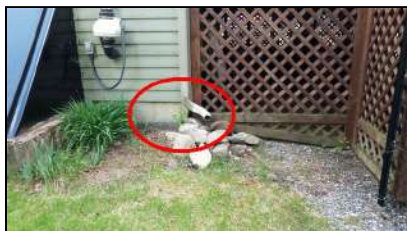
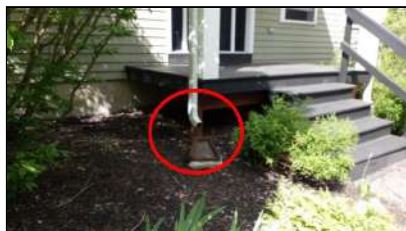
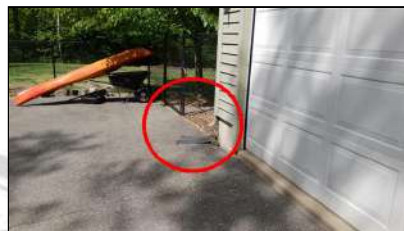
**1.1 (2)** Recommend client install extensions to all downspouts of at least 3" to shed water from house and splash blocks to prevent erosion.

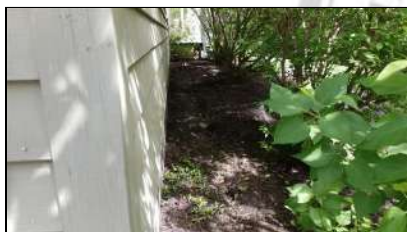
**1.1 (3)** Recommend client consider installation of additional gutters on front side of garage, with proper downspouts and extensions, to shed water away from property to avoid erosion and/or water intrusion.

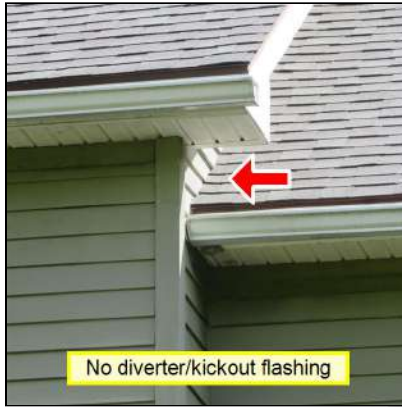
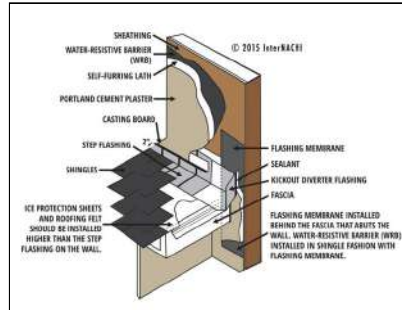
**1.2 (2)** No kickout or diverter flashing to shed water away from side of main house where roof for garage meets the side of the house. To avoid possible rainwater intrusion, I recommend client consider having kickout flashing installed.

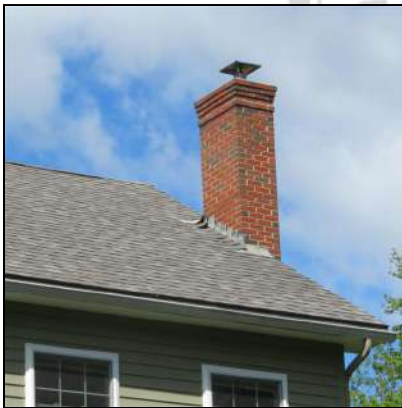
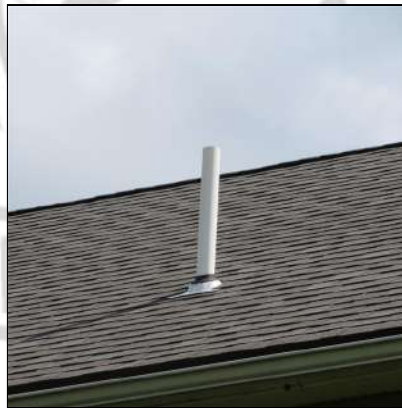
**1.3 (2)** I recommend a cap be installed for the entire chimney top, to keep rain, snow, animals and debris from getting into the chimney and possibly damaging the liner or chimney.

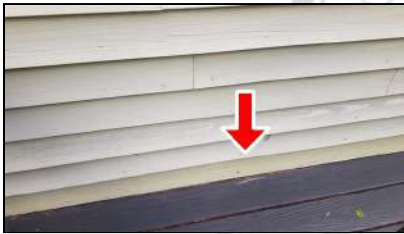
**2.0 (1)** Section of clapboard siding above deck is loose and needs to be secured properly.

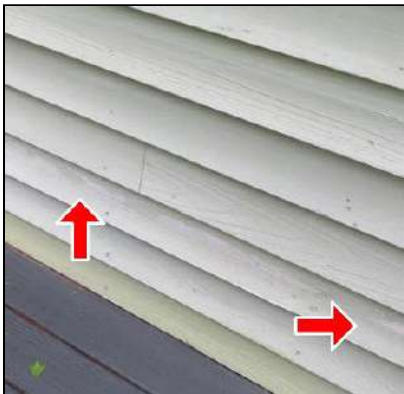
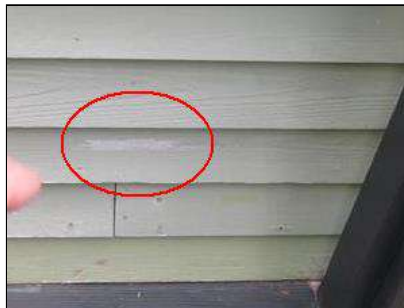
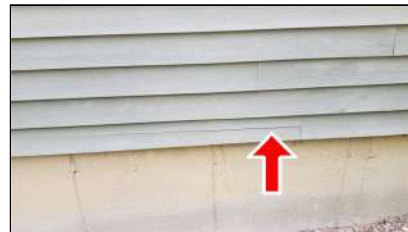
**2.0 (2)** Small areas of bare wood on siding on rear of house. Also several pieces of clapboard siding have cracks. Recommend any bare wood be primed and painted and cracks sealed or siding otherwise repaired to prevent moisture intrusion and extend life of siding.

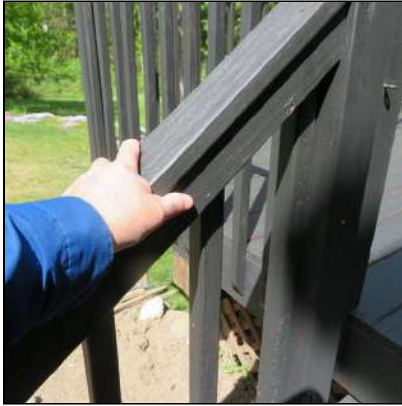
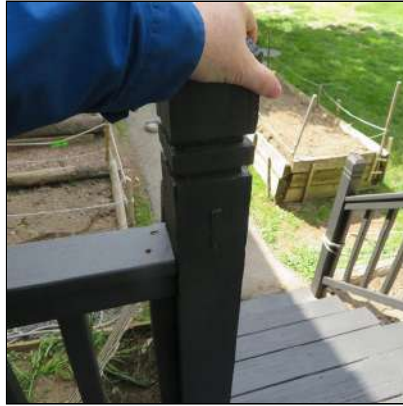
**2.4 (3)** Railing systems for steps to deck and sections of railing system for deck are loose in areas. This is common for railing systems as they loosen over the course of time. Recommend the railing system be tightened or repaired as necessary.

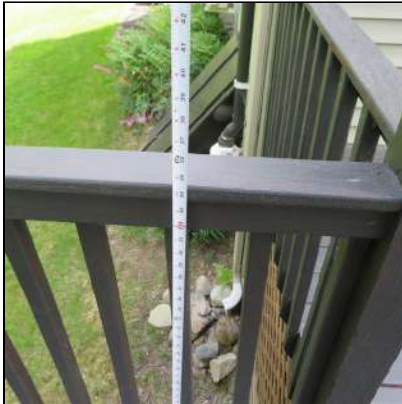
**2.4 (4)** Railing system for addition to deck where gazebo is located is approximately 34" tall. Recommend guardrails be repaired to meet the current minimum height requirement of 36".

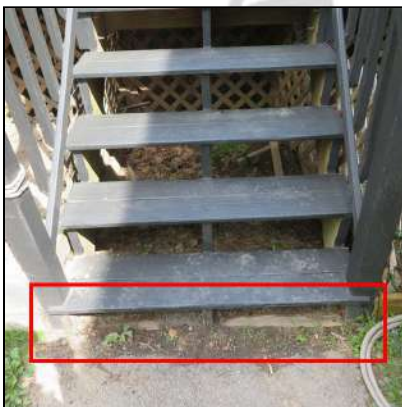
**2.5** Steps to deck are resting on piece of wood. I recommend steps be placed on stone or concrete be installed to prolong useful life of the steps.

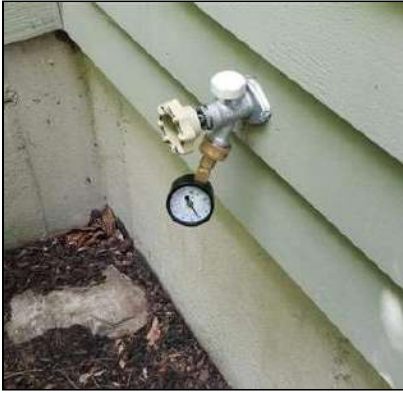
**2.9** There are spigots on the front and rear of the house. I tested the water pressure at the spigot at the front of the house and the pressure was approximately 65 pounds per square inch (PSI). This is within the generally acceptable limits of 40 PSI and 80 PSI .

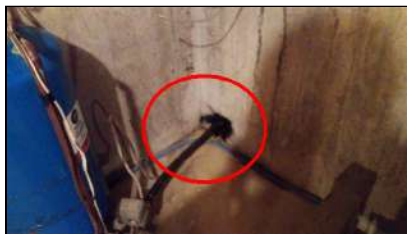
**3.0 (1)** According to the disclosure, there was "minor seepage front right hand corner (of basement) - never had a problem until fall of 2019. Seller investigating." The seller advised me at the inspection that he determined the moisture was coming from around water line from well and he sealed around the pipe. No evidence of moisture intrusion observed at time of inspection. Recommend this area be monitored.

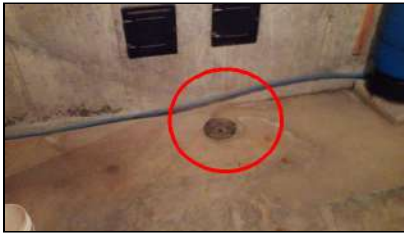
**3.3 (1)** Floor drain in basement to right of the boiler. Did not observe where the floor drain pipe terminates. Recommend client(s) run a hose in the drain to determine where it exhausts and if it is functioning. Also recommend a perforated cap be installed on the drain pipe to keep it from getting clogged and to keep animals out of the pipe.

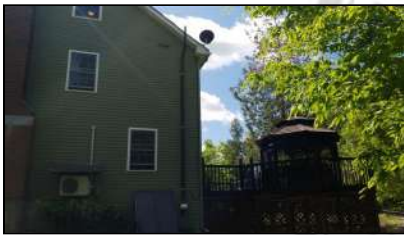
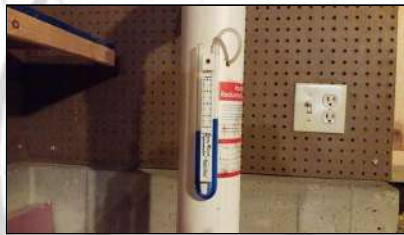
**3.5** Radon mitigation system installed with fan on exterior right side of the house. Vacuum tube (manometer) on side of radon mitigation system does **not** provide any information regarding the amount of radon gas in the house. It only determines if the fan on the system is pulling air from under the floor of the basement. It is important that the vacuum tube be periodically inspected by the client(s) to confirm the fan is operating. Please refer to Section 17.0 regarding periodically testing the air in the house for radon gas.

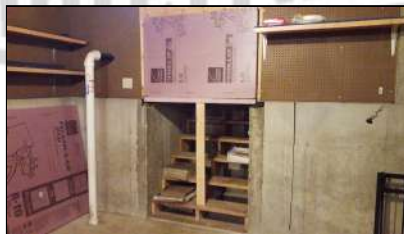
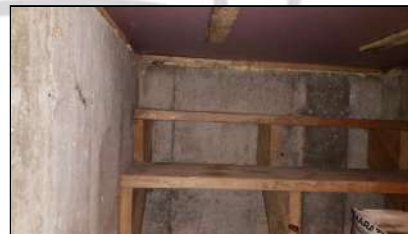
**3.7** Bulk head on right side of house. Unable to clearly observe the bulkhead due to insulation blocking view. Recommend bulk head be inspected once insulation is removed.

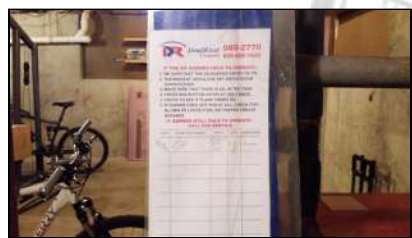
4.0 (2) According to the Disclosure, the boiler was serviced in 3/2020 by Dead River. This was confirmed by service tag on boiler. I recommend that the heating system be inspected and serviced annually by a qualified HVAC contractor. I also recommend the client consider having a service plan for the heating system.

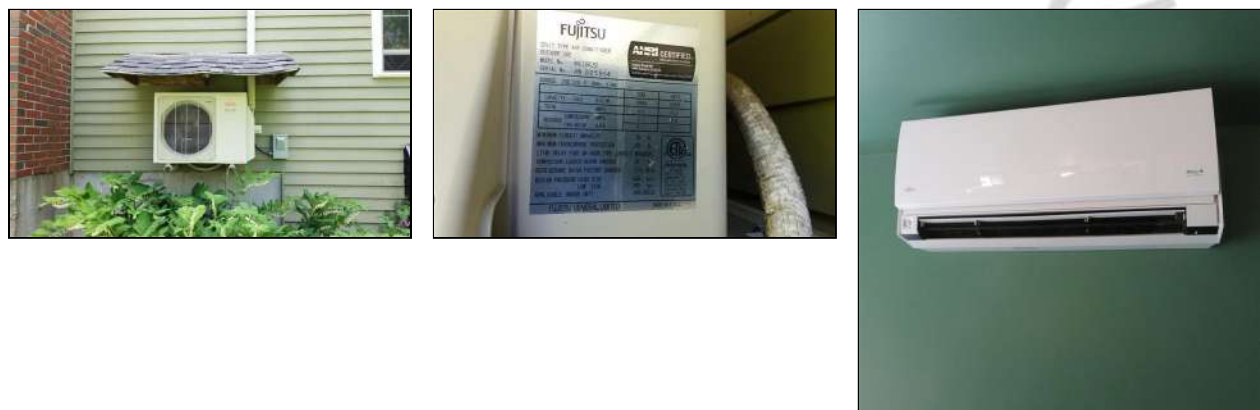
4.0 (3) Fujitsu split type heat pump/air conditioners located in the living room and room over garage. The units are 16,000 BTU for heat and 12,000 BTU for cooling. Unable to determine date of manufactured based on serial numbers. The average life expectancy of a split type heat pump is 14 to 15 years.

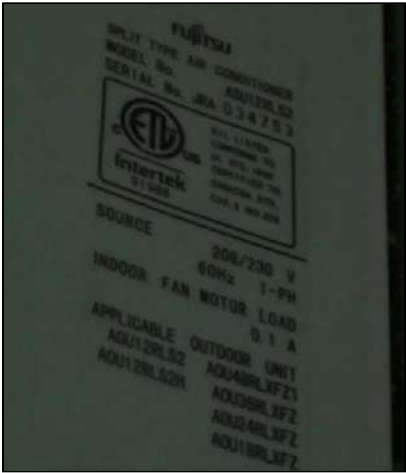
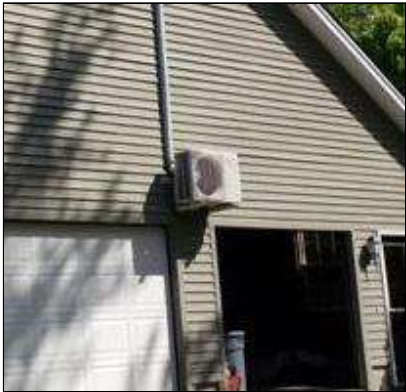
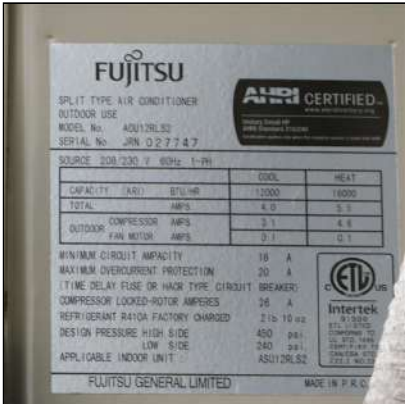
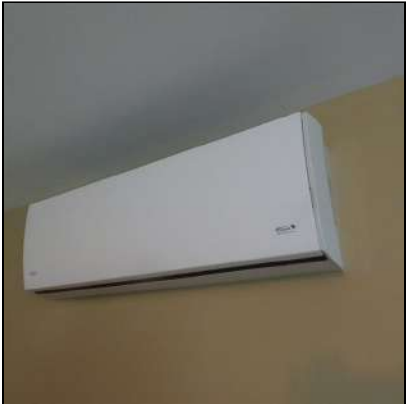
**4.0 (4)** Heat pump compressors and head units require periodic maintenance, including cleaning the filter(s). No information regarding when the units were last serviced or cleaned. Recommend client read manual to determine what manufacturer recommends for a maintenance schedule.

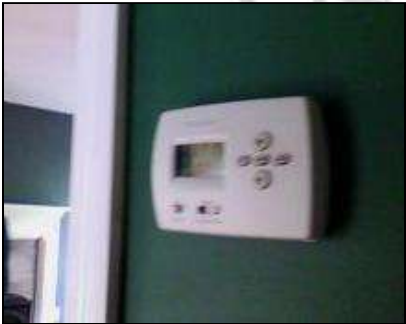
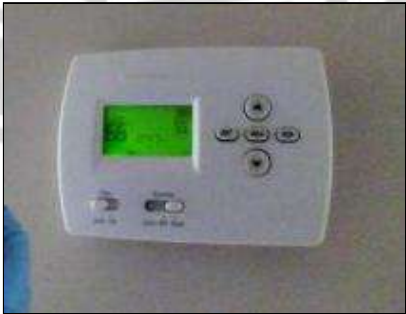
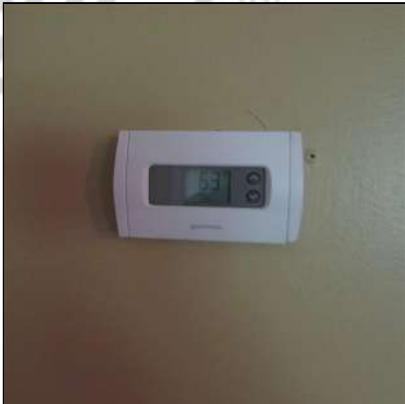
**4.1 (1)** All thermostats operated properly unless otherwise noted.

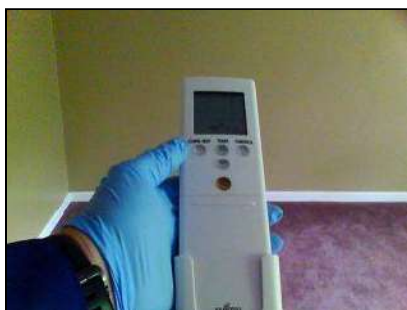
**4.1 (3)** Remote control for each heat pump and each functioned properly at time of inspection.

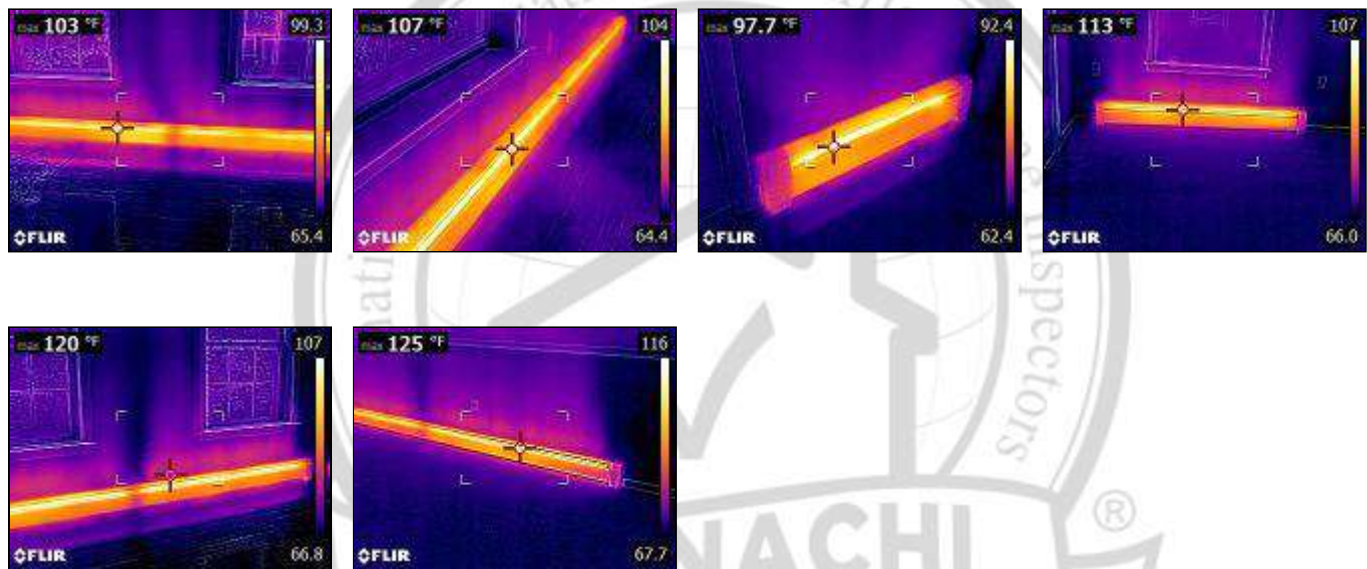
4.3 (1) All hot water baseboard registers inspected with thermal imaging camera and except as otherwise noted the registers operated properly. Please refer to representative photos of sections of the baseboard.

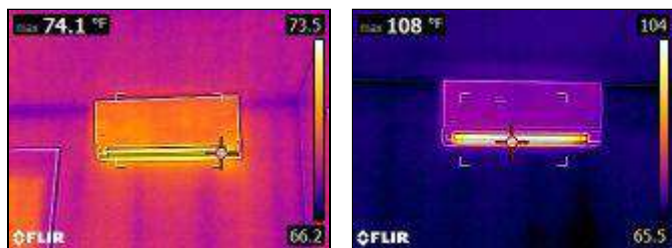
**4.3 (3)** Heat pumps inspected with thermal imaging camera.

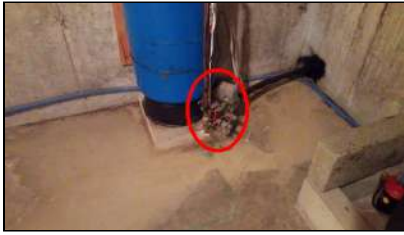
**5.0** (1) The main water shut-off valve is located near the bottom of the air bladder tank in the basement.

**5.0** (2) I did not operate the main water shut-off valve. I recommend the client(s) test the valve before moving into the property and periodically thereafter to make sure it is functioning properly.

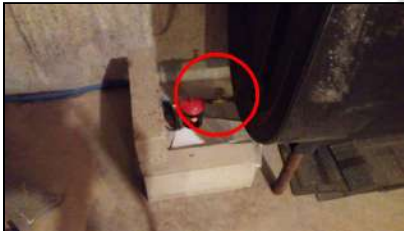
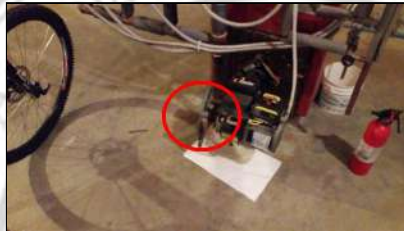
**5.1** (1) Main oil shut-off valve located at bottom of oil tank near the oil filter. There is also a shut-off valve next to the burner on the boiler

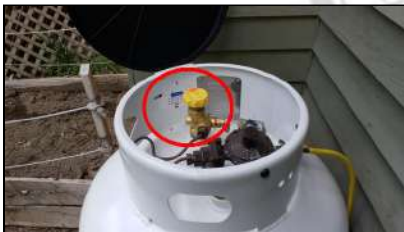
**5.1** (2) The main fuel shut-off for the propane is at the tank outside.

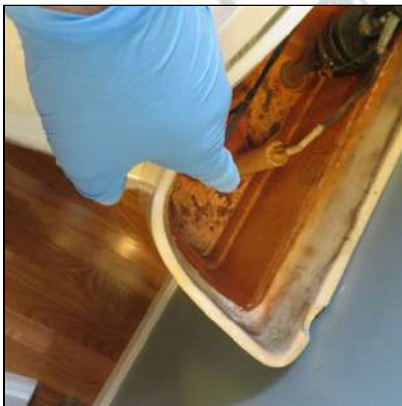
**5.3 (2)** Toilet tanks have staining consistent with iron or other contaminants in the water. The water is being tested for contaminants. Please refer to Section 15.

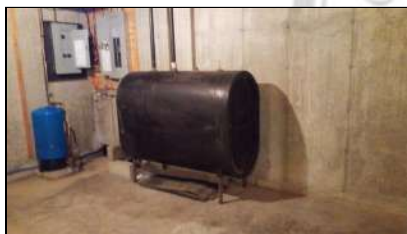
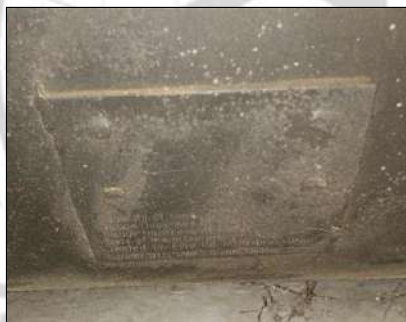
**5.6 (2)** The oil tank is located in the basement. The tank is 275 gallons. Unable to determine date of manufacture from tag on the tank.

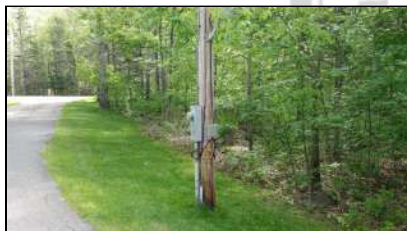
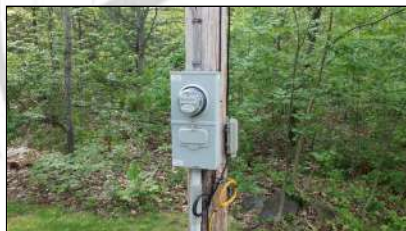
**6.0** Electrical service entrance and meter on left side of the driveway.

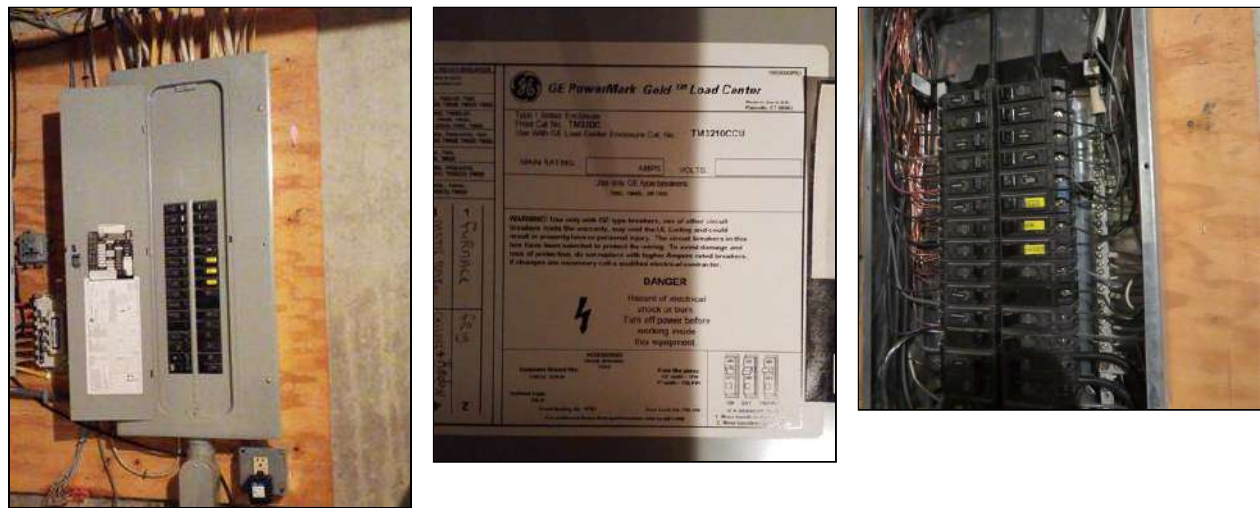
6.1 (1) 100 amp General Electric main service panel located in the basement.

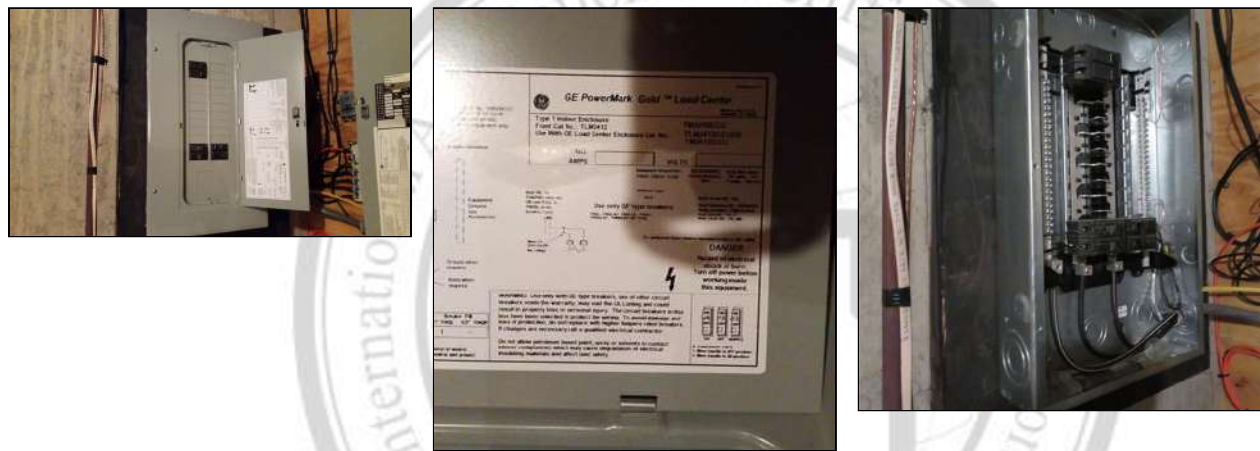
6.1 (2) 100 amp General Electric distribution panel located in the basement for heat pumps.

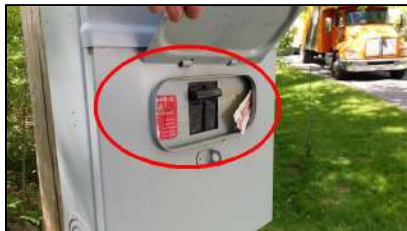
**6.1 (4)** Main disconnect switch below the electric meter on the exterior. I recommend client install a lock on the cover for the switch.

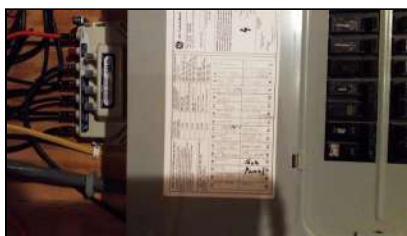
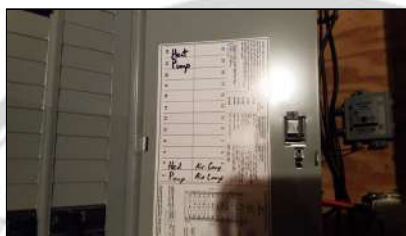
**6.2 (1)** Recommend client confirm accuracy of labeling of circuit breakers and that all circuits be labeled. Three Arc Fault Circuit Interrupter (AFCI) circuit breakers in main service panel marked for the bedrooms. Recommend the AFCI circuit breakers be tested periodically to determine if they are functioning properly.

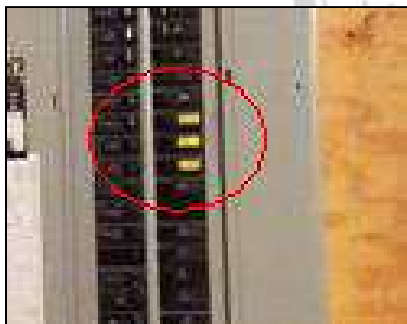
**6.2 (2)** Several GFCI circuit breakers. Recommend the GFCI circuit breakers be tested periodically to determine if they are functioning properly. Please refer to Section 6.4(1).

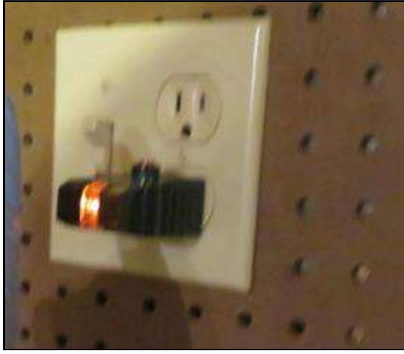
**6.3 (1)** Receptacle near bulk head entrance in basement is not grounded. Recommend the receptacle be repaired or replaced by a qualified contractor so it is properly grounded.

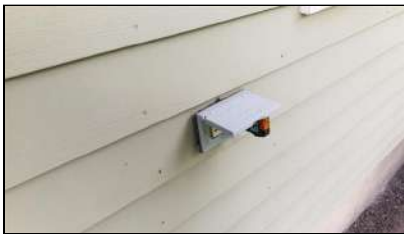
**6.3 (2)** Exterior receptacle by front door is loose. Recommend it be properly secured.

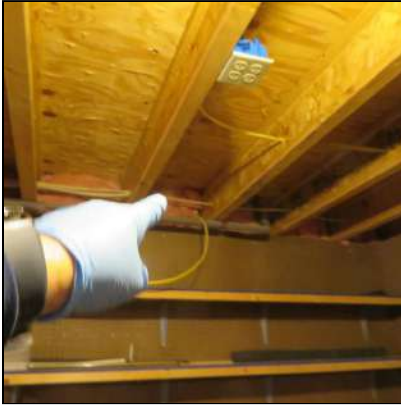
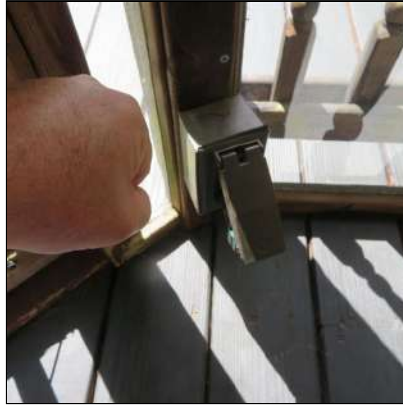
**6.3 (4)** Extension cord used to supply power to gazebo. Extension cords are not supposed to be used for permanent wiring. Recommend wiring to gazebo be hard wired and that any receptacles in gazebo be GFCI protected.

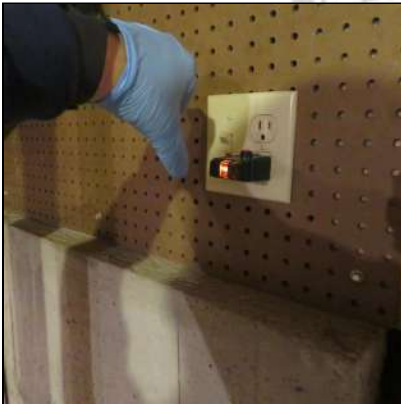
**6.4 (2)** Receptacles in basement not GFCI or GFCI protected with exception of receptacle near service panel. Recommend all receptacles in basement be replaced with GFCI, or otherwise be GFCI protected.

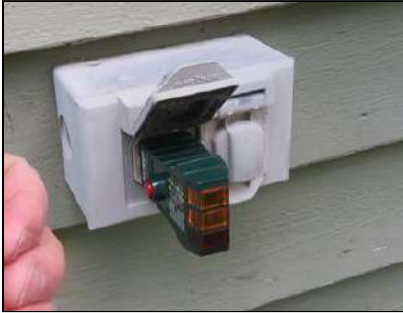
**6.4** (3) Exterior receptacle by door to deck GFCI protected and tripped when tested. However, unable to locate GFCI the receptacle is protected by. Recommend GFCI receptacle be located so it can be reset.

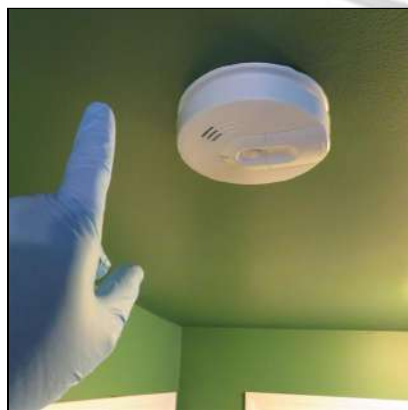
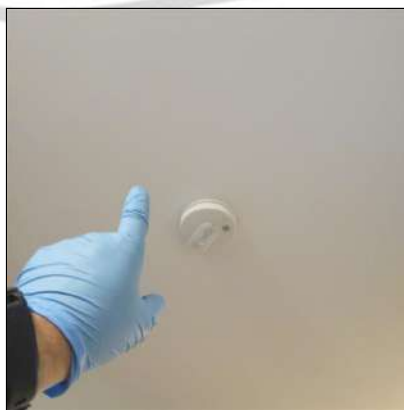
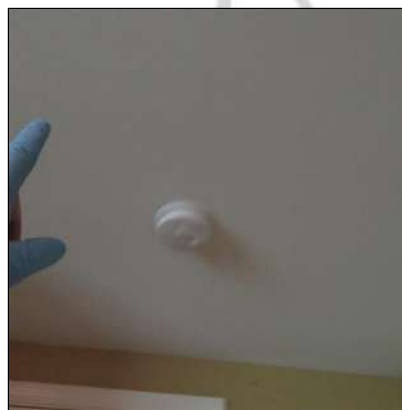
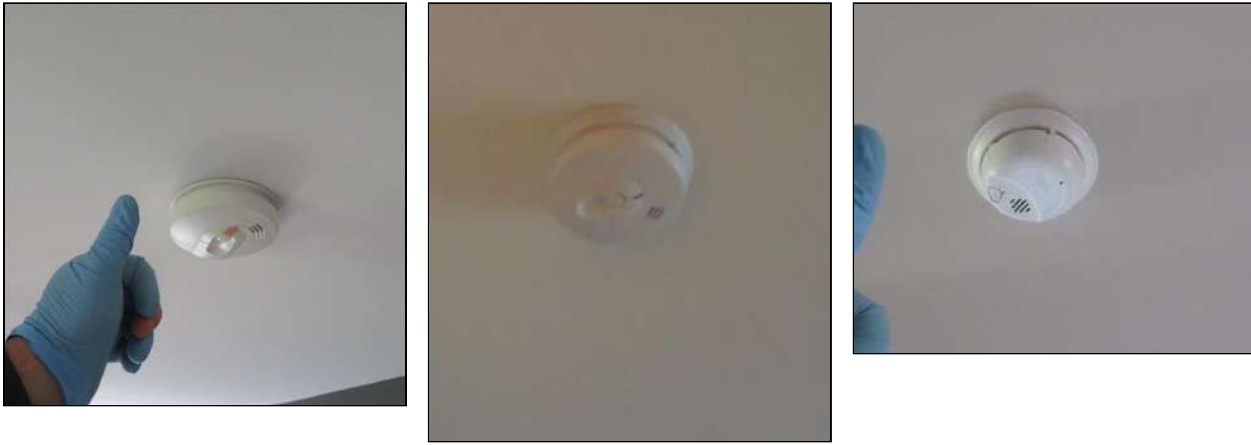
**6.7 (3)** Hard wired smoke detectors on 1st floor, in 2nd floor hallways, all bedrooms, room over garage and 3rd floor. All detectors were tested and operated.

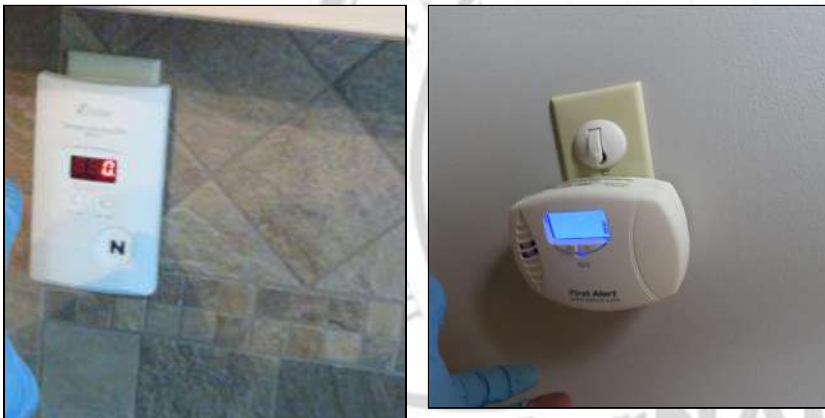
**6.7 (5)** Plug in CO detectors in kitchen and 2nd floor hallway. I recommend the client install additional CO detector(s), powered by both battery and electricity, in compliance with Maine law. An option is to replace smoke only detectors in hallway(s) with combination smoke/CO detector(s).

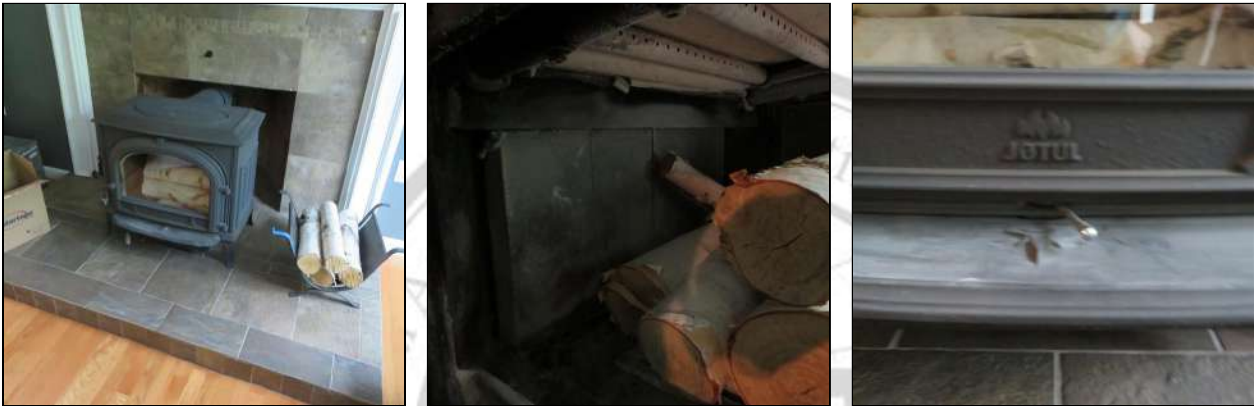
7.1 Jotul wood stove in the living room.

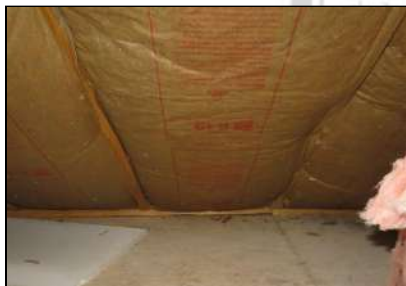
**8.0 (2)** No access to attic over main house so unable to observe insulation in the attic. Did observe R-19 fiberglass batt insulation under roof deck behind knee wall on front of house on 3rd floor. Recommend insulation in attic over main house be inspected if access is made to the attic.

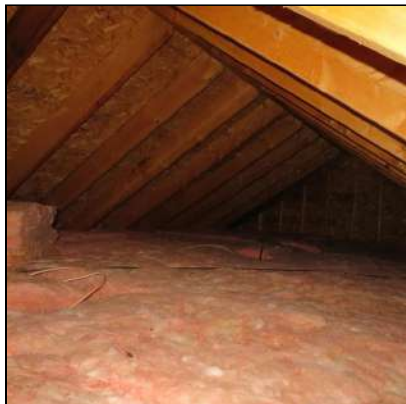
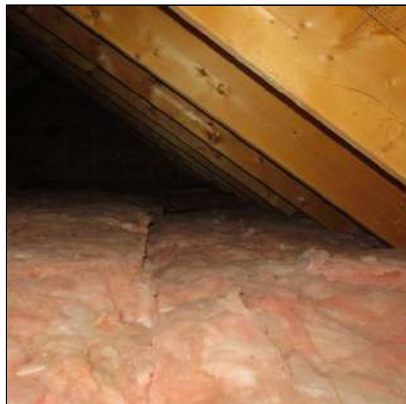
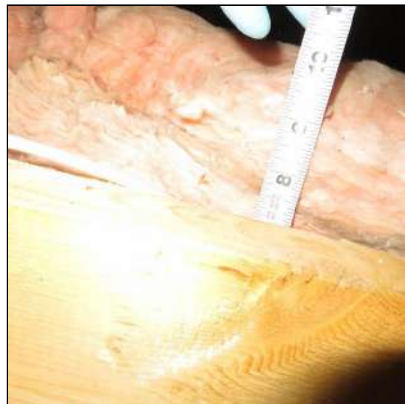
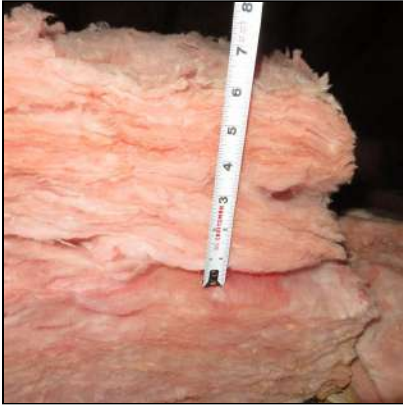
**8.0 (3)** Two layers of fiberglass batt insulation in attic, for total of approximately 12" to 14". The R-value of fiberglass insulation is approximately 3.1 to 3.4 per inch.

**8.0 (4)** Recommend client consult with insulation contractor regarding installing additional insulation in attic(s). Please refer to Home Energy Report (Section 14.0).

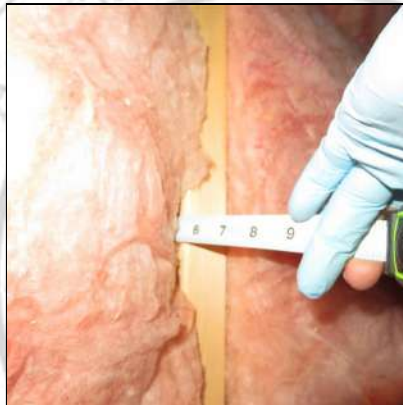
**8.1** Unable to observe insulation in walls with exception of area behind knee wall on front side of house on 3rd floor where 6" of fiberglass batt insulation present. The R-value of fiberglass insulation is approximately 3.1 to 3.4 per inch.

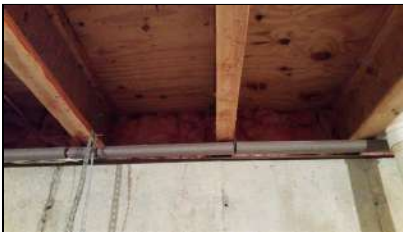
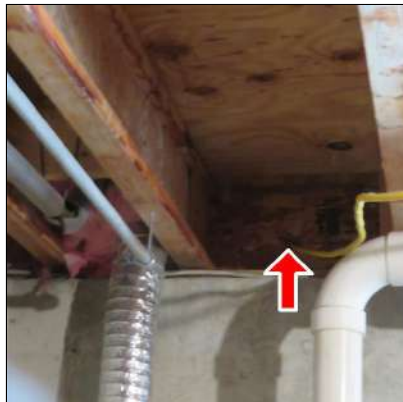
**8.2** Fiberglass insulation in most of rim joists in basement. No insulation in rim joist to right of where dryer vents to exterior. Recommend insulation be installed in all rim joists where missing.

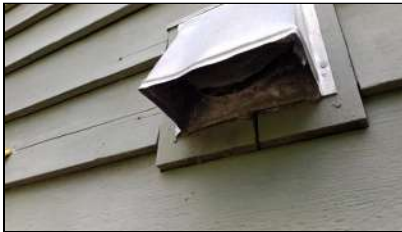
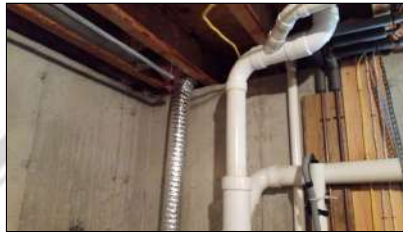
**8.5 (1)** There was lint in the exhaust vent which should be removed and the vent and pipe should be checked periodically and cleaned as necessary as part of the routine maintenance of the property to prevent the risk of fire and for the efficiency of the dryer.

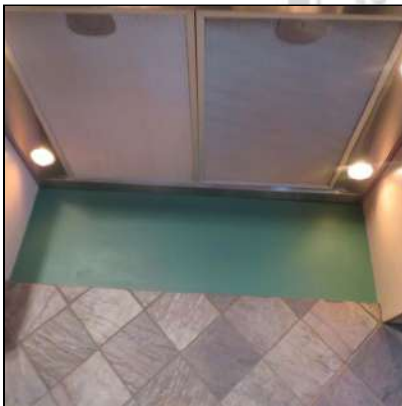
**8.5 (2)** The metal filters for the range hood should be cleaned and/or replaced following recommendations of manufacturer.

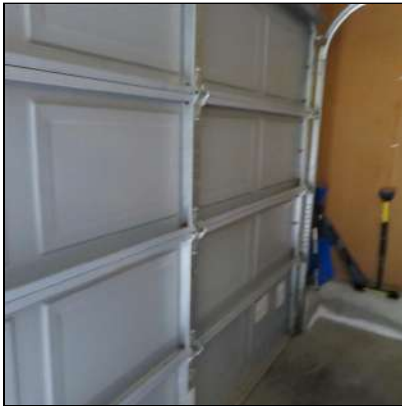
**8.8** No insulation in overhead garage doors. Recommend insulation be installed

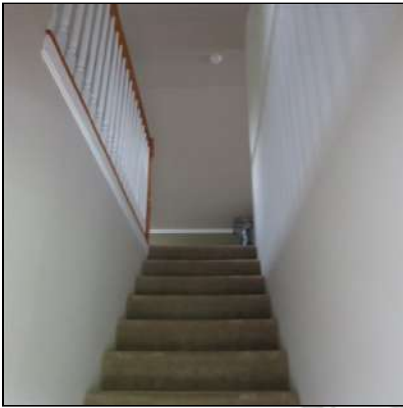
**9.3 (2)** Recommend a handrail system which complies with current safety standards be installed for the stairs to the 3rd floor.

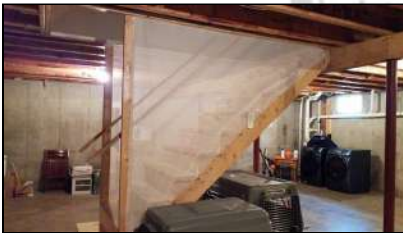
**9.3 (3)** Recommend a handrail system which complies with current safety standards be installed for the stairs to the basement.

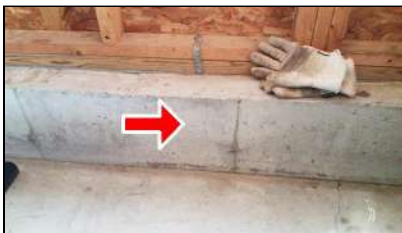
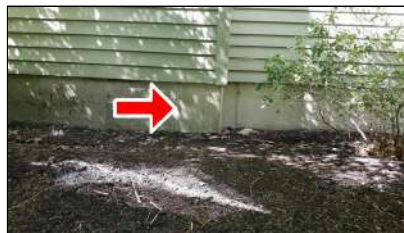
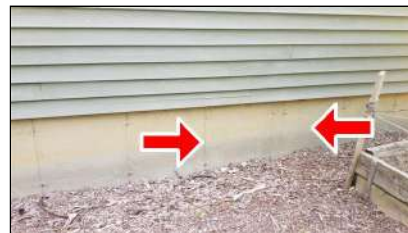
**10.0** Several minor cracks in concrete foundation wall for garage, but no evidence of any structural issues. Cracks of this type are common. Recommend cracks be monitored and if any 1/4" or larger that they be sealed.

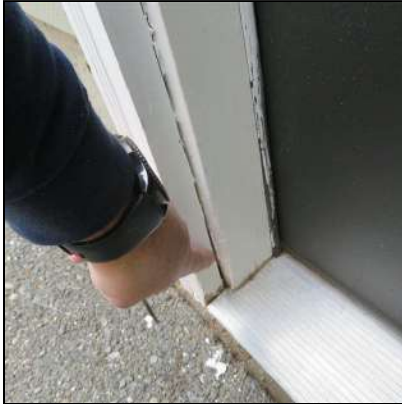
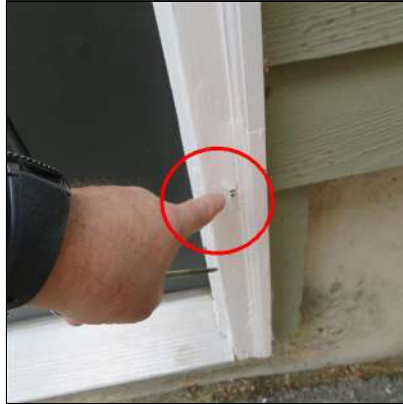
**10.4 (2)** Gap between trim on left side of entrance door to garage and missing paint on section of the trim for door. Recommend gap be sealed and any bare wood be primed and painted to prevent moisture intrusion.

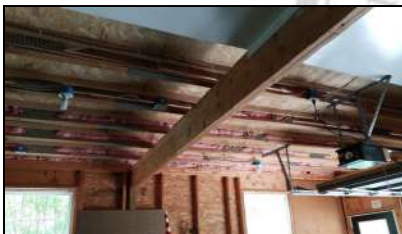
**10.5 (2)** No drywall for garage ceiling under storage area. There is finished drywall for ceiling under living space over the garage. Unable to determine thickness of drywall in garage ceiling. Recommend thickness be confirmed. If it does not meet requirements for firewall separation, I recommend it be repaired so it does.

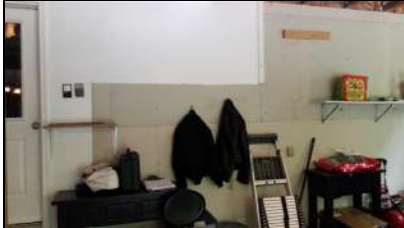
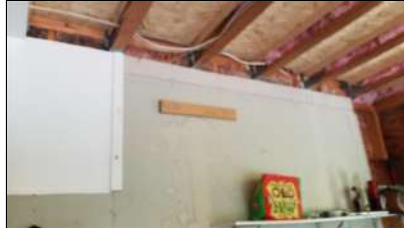
**10.6 (2)** Wall between garage and residence has drywall, but all joints do not have tape or joint compound. Wall is required to be firewall separation. This means that any penetration must be sealed (fire rated caulking recommended for small gaps around the pipes, air ducts, door frames, etc). Also, all drywall seams must be taped / finished with joint compound. Recommend joints of sheetrock have tape and joint compound applied by qualified contractor.

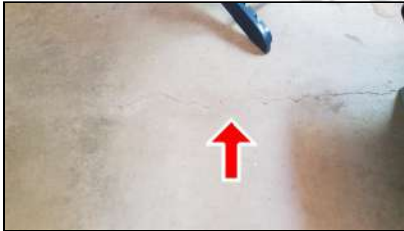
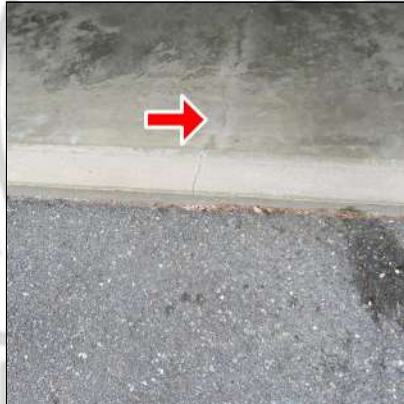
**10.8 (1)** Cracks in garage floor, but no evidence of any structural issues. Cracks of this type are common. Recommend cracks be monitored and if any 1/4" or larger that they be sealed.

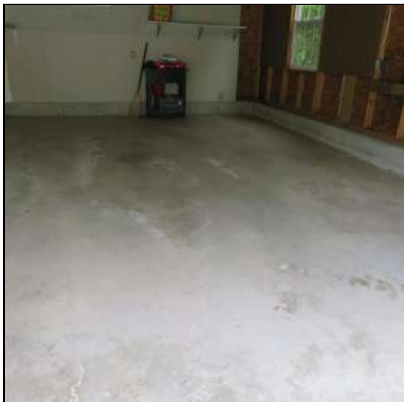
**10.8 (2)** Recommend garage floor be sealed to prolong its useful life.

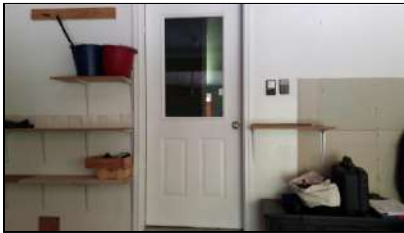
**10.12 (2)** Metal door with double pane glass from garage to residence. The door does not have any labeling indicating it is fire rated and did not appear to be filled with concrete. If the door is not fire rated and a fire occurs in garage, the occupant door may not afford protection until fireman arrive. Recommend clients investigate this further. If the door is not fire rated I recommend it be upgraded with a fire rated door.

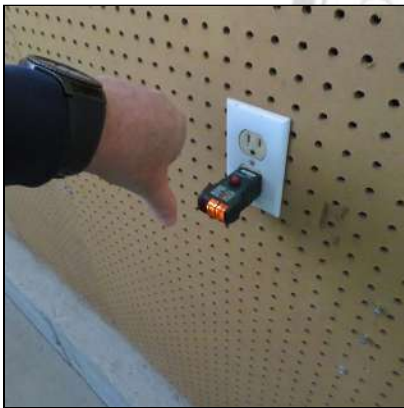
**10.15 (1)** Receptacles inside garage are not GFCI protected. Recommend all receptacles on interior of garage be GFCI, or GFCI protected. See Section 6.4.

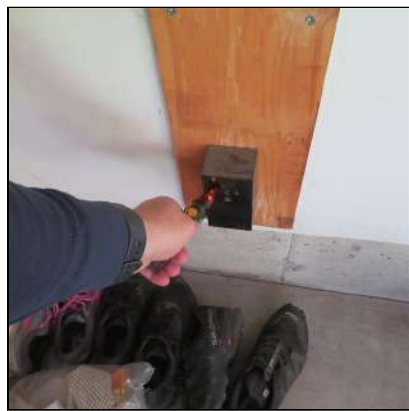
10.15 (2) 220 volt receptacle in garage, possibly used for clothes dryer, welding equipment or compressor s live.

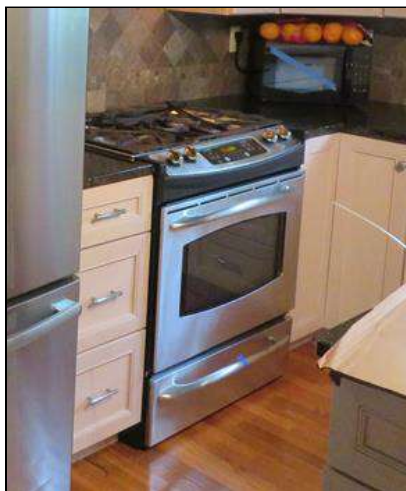
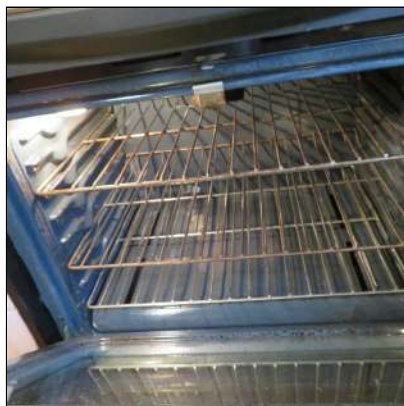
**11.4 (1)** General Electric gas range/oven. The range/oven appears to have been manufactured in 10/07. The average life expectancy of a gas range/oven is 15 to 17 years.

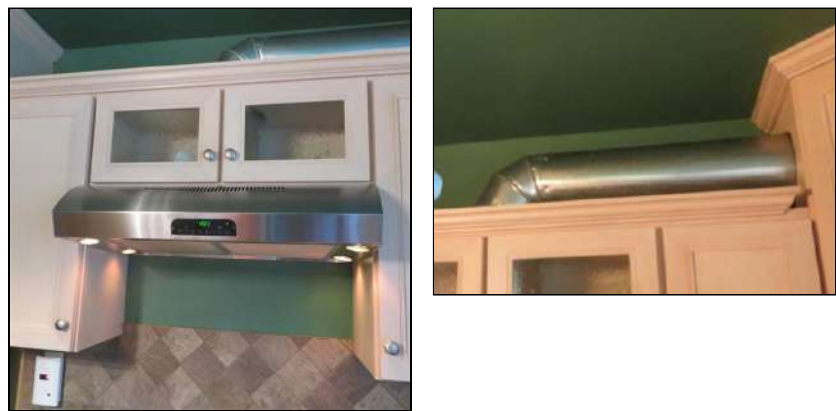
**11.5** Range hood vents to exterior of home. Unable to determine manufacturer or date of manufacture. The average life expectancy of a range hood is 14 years. Please refer to Section 8.5 for information regarding the venting of the hood.

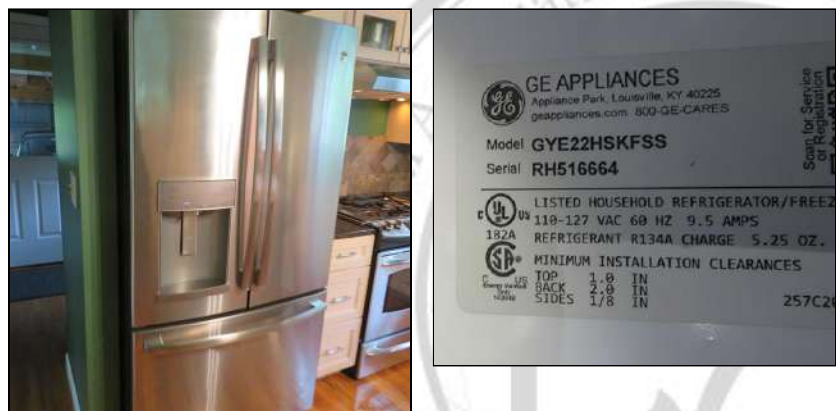
**11.6 (1)** General Electric refrigerator appears to have been manufactured in 8/05 or 8/17. The average life expectancy of a refrigerator is 9 to 13 years.

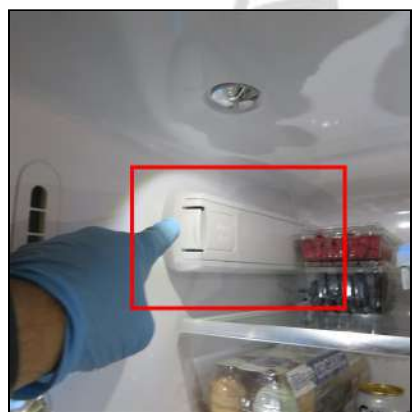
**11.6 (2)** Built in water filter in refrigerator which should be replaced periodically following recommendations of the manufacturer.

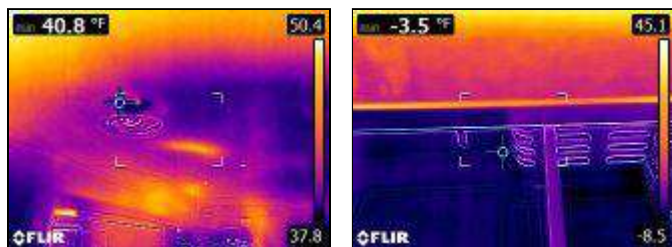
**11.6 (3)** Internal temperature of the refrigerator was approximately 40 F. The generally recommended temperature for a refrigerator is from 35 F to 40 F. The temperature of the freezer was approximately -3 F. The recommended

temperature of a freezer is 0 F. I recommend the client read the manual regarding setting the temperature for the refrigerator and freezer.

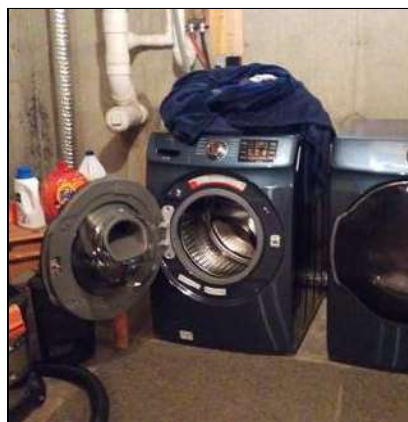
**11.8 (1)** Samsung clothes washer appears to have been manufactured in 2/17. The average life expectancy of a clothes washer is 5 to 15 years.

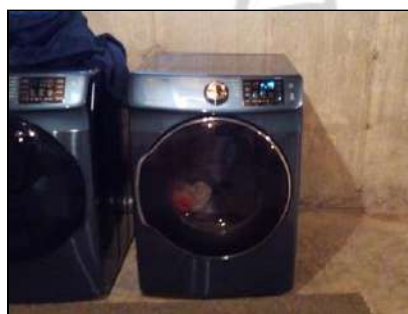
**11.9** Samsung clothes dryer appears to have been manufactured in 11/16. The average life expectancy of a clothes dryer is 13 years . See Section 8.5 for information concerning the venting of the dryer.

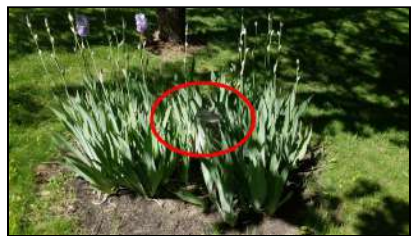
13.0 (1) The well is located on the front yard to the right of the driveway. I did not remove the cover to the well. I recommend the cover be removed and the wiring for the well pump inspected. If this is done, some water quality experts recommend a well be chlorinated anytime the cover is removed.

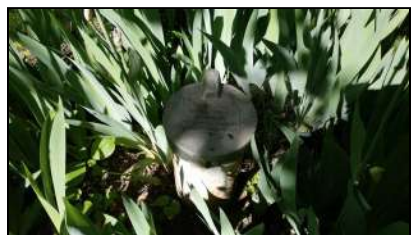
13.0 (2) Although the well cap is functioning, I recommend the client(s) consider installing a sanitary cap for the well head to keep insects and animals out of the well.

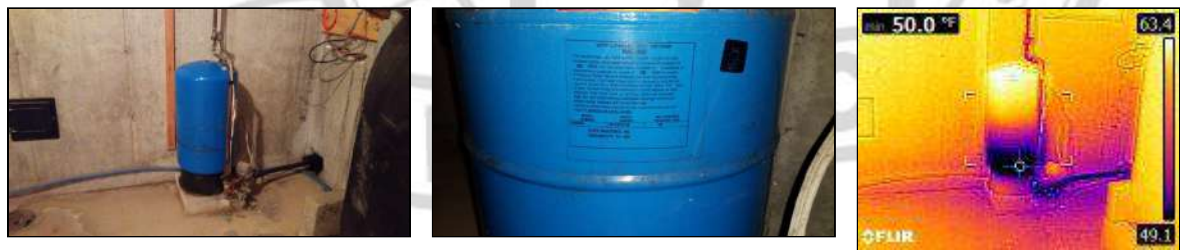
13.1 (1) There is a State air bladder tank which was apparently manufactured in 9/07. The average life expectancy of an air bladder tank is 7 years. I tested the tank using the knocking technique and with thermal imaging camera to confirm the air bladder was intact.

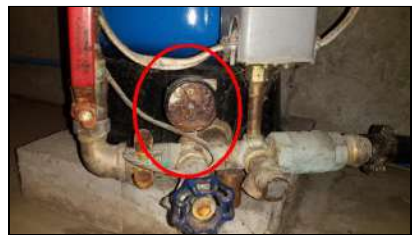
**13.1** (2) Unable to read the water pressure gauge at the base of the air pressure tank in the basement. Recommend the gauge be replaced so the pressure can be determined as part of a routine maintenance schedule or for servicing purposes. The generally acceptable limits for well water pressure at a residence is between 40 PSI and 80 PSI . I tested the water pressure at the exterior spigot. Please refer to Section 2.9.
